## Mixed Use Development

Hydrogeological Investigation

11 to 25 Yorkville Avenue and 16 to 18 Cumberland Street,  
Toronto, Ontario

MRK-00242474-A0

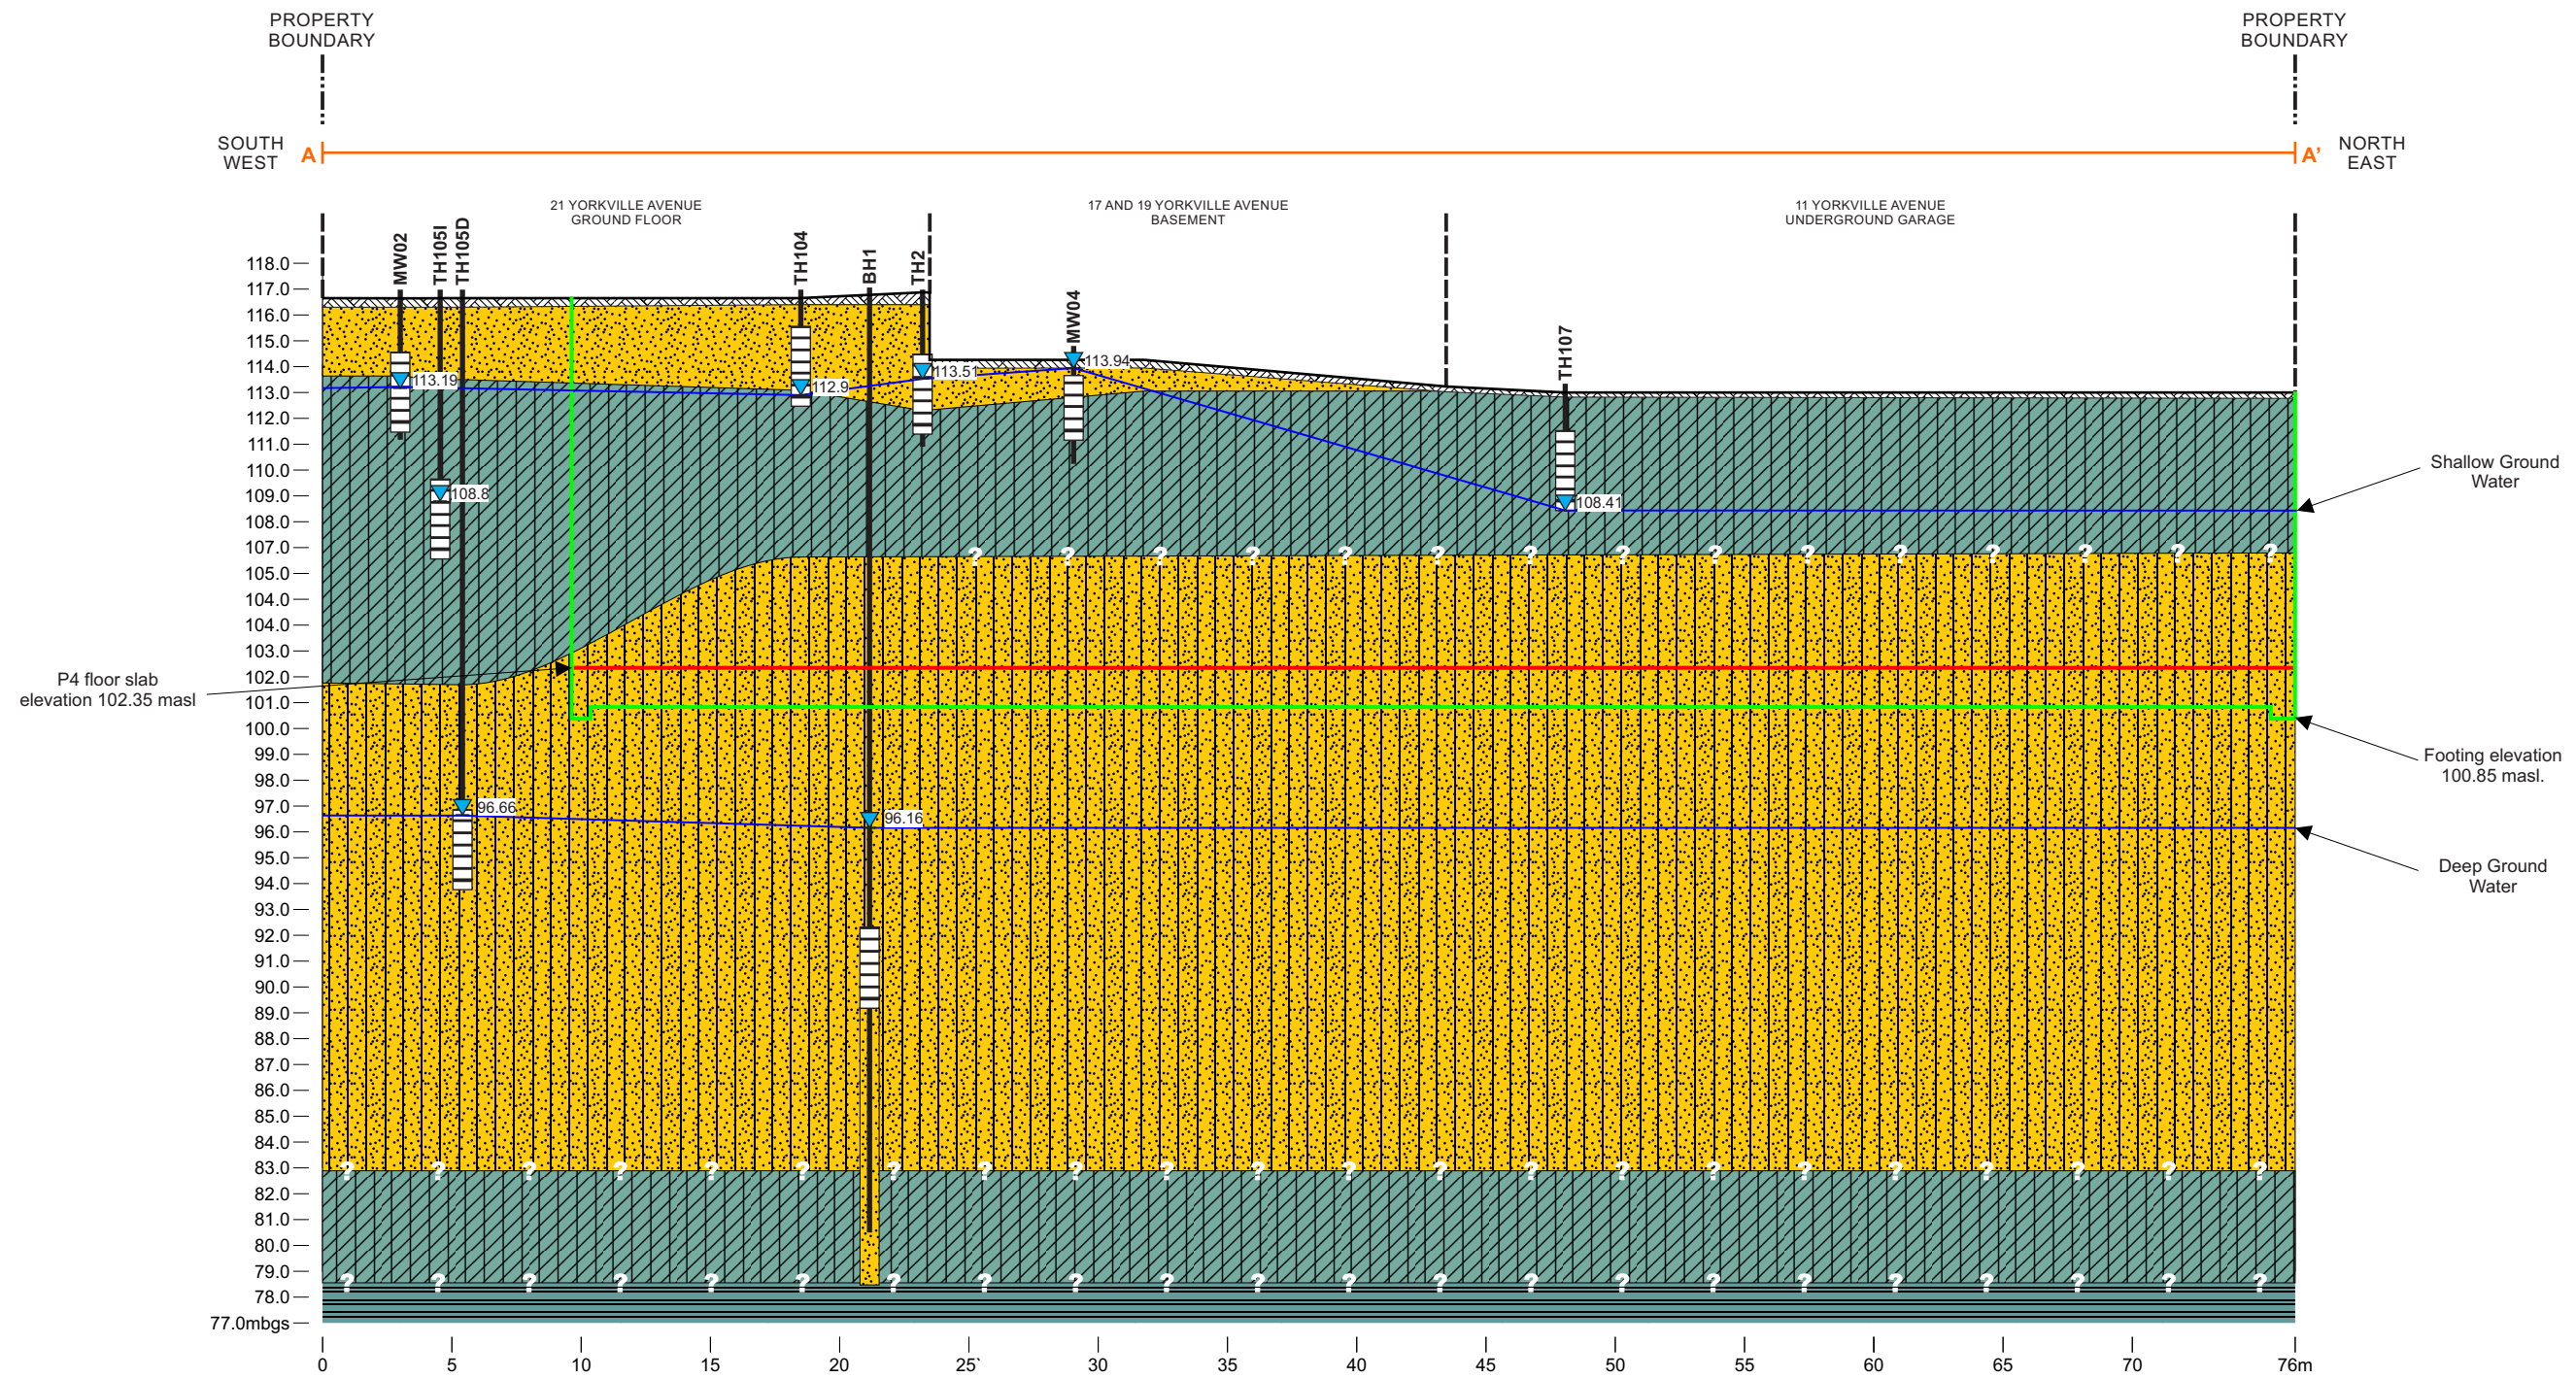
**SCALE:**  
VERTICAL & HORIZONTAL SCALE 1:1

**SOURCE:**  
BASED ON FIELD  
OBSERVATIONS BY EXP STAFF

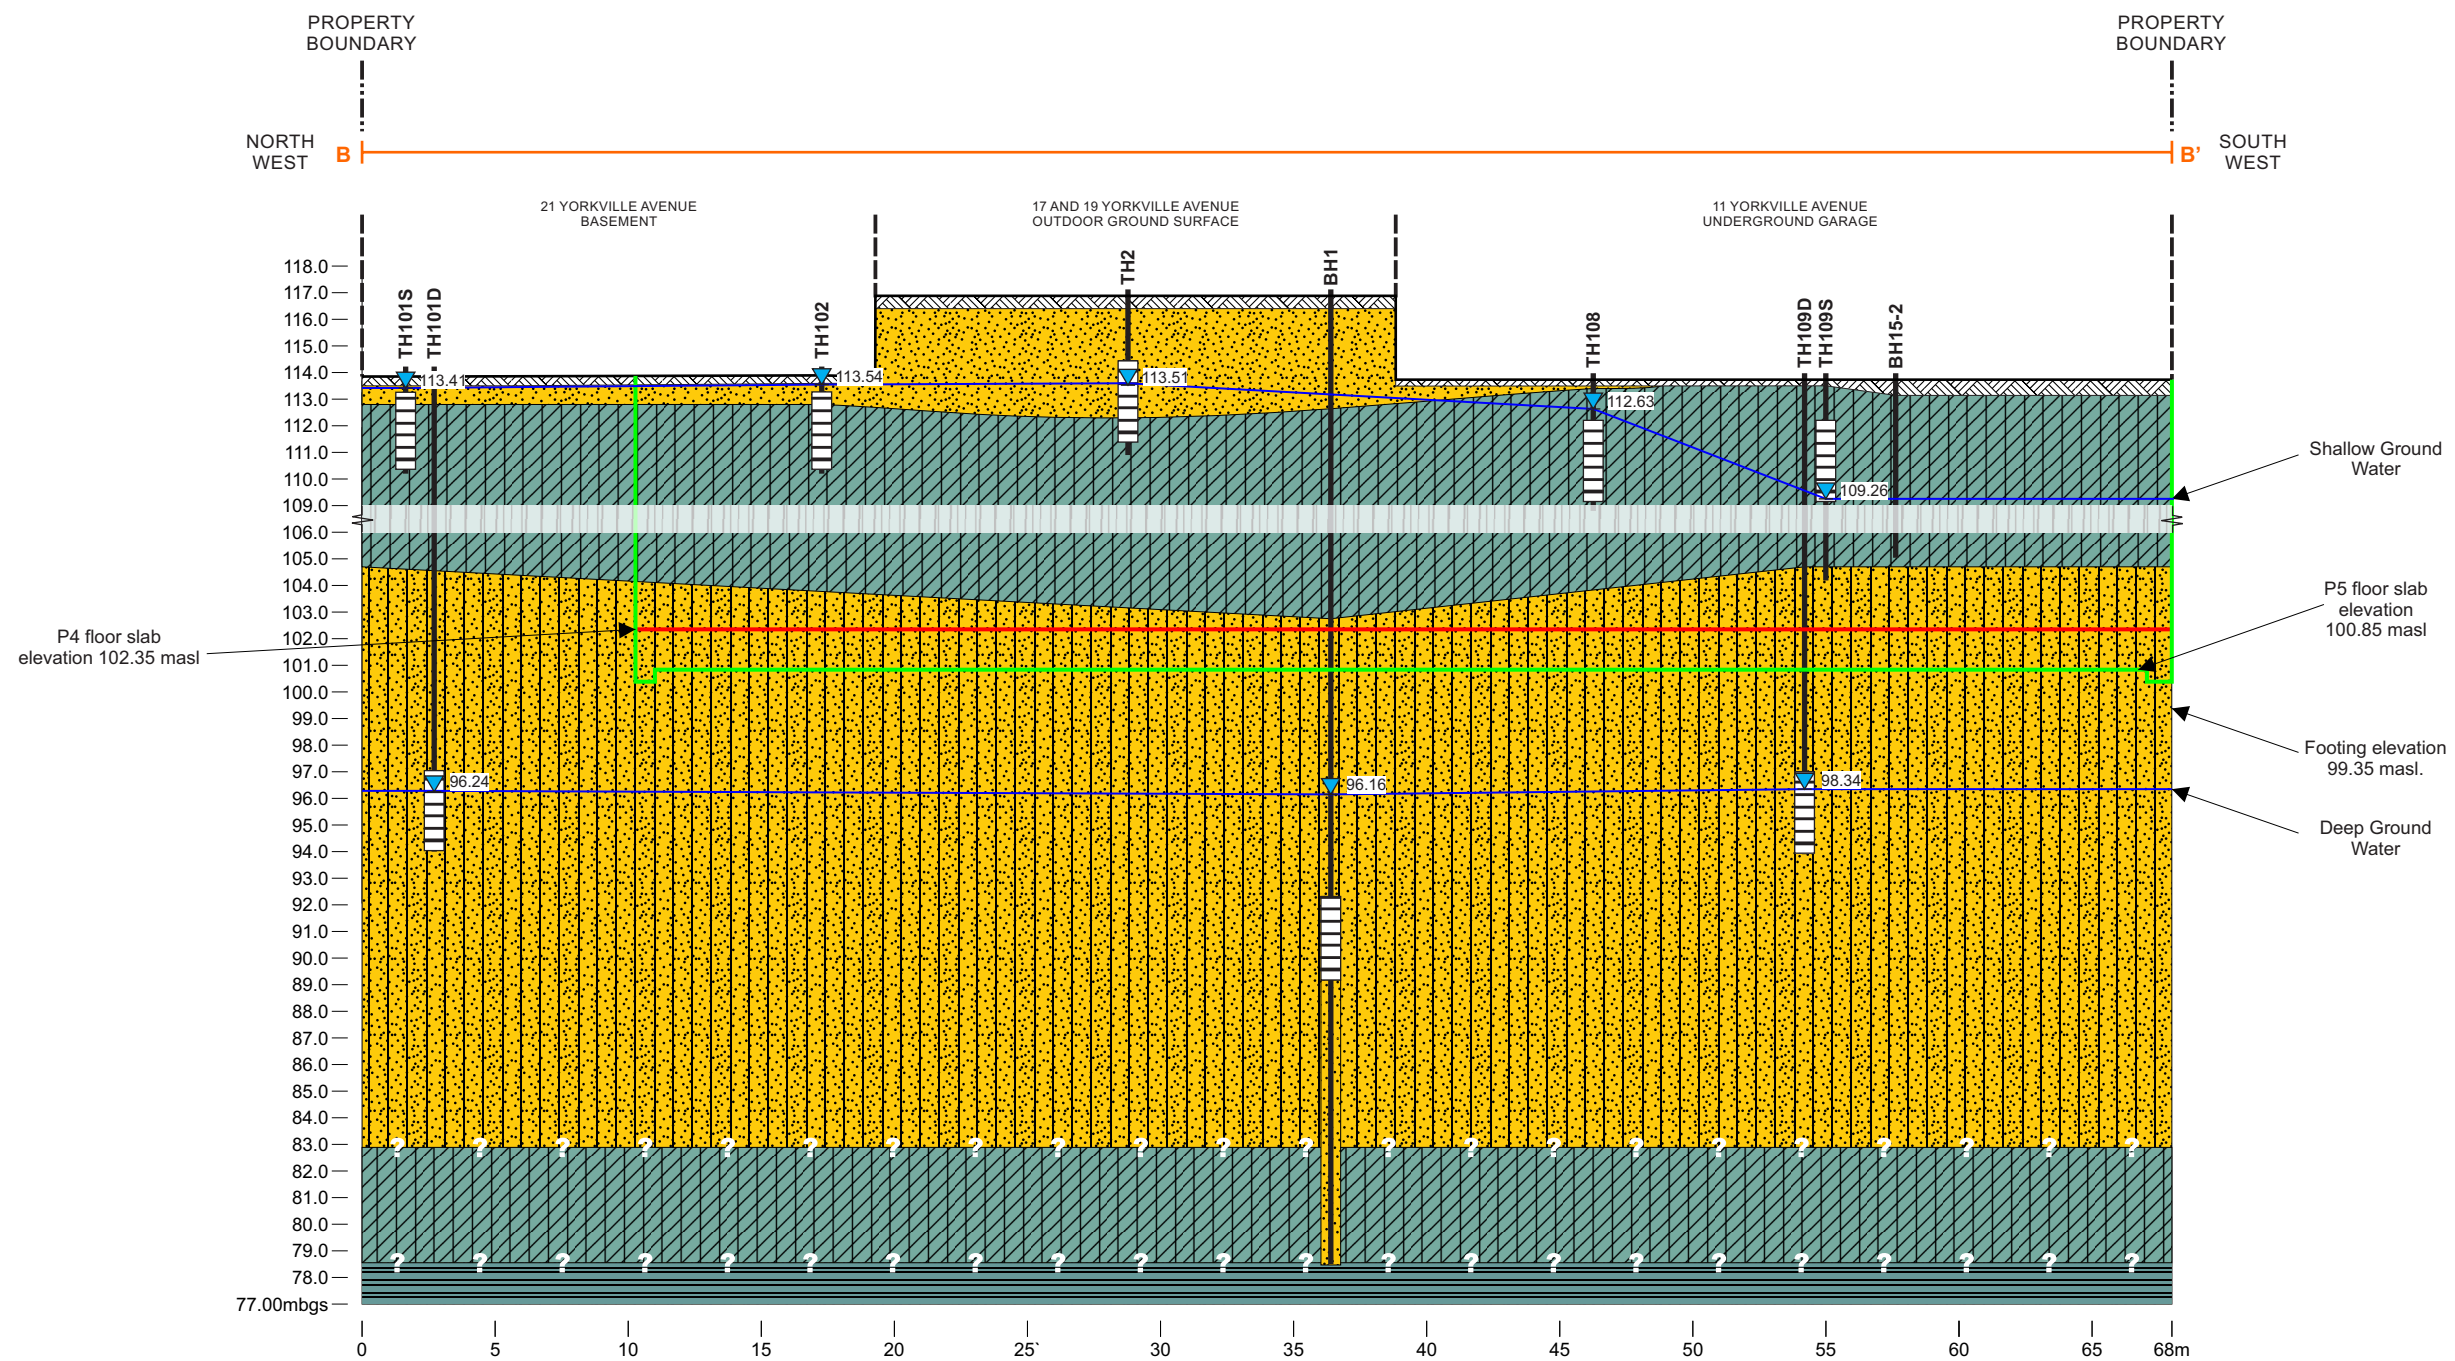
**SCALE:**  
VERTICAL & HORIZONTAL SCALE 1:1

**SOURCE:**  
BASED ON FIELD  
OBSERVATIONS BY EXP STAFF
