Phase One Environmental Site Assessment

Phase One Environmental Site Assessment
11 Yorkville Avenue, Toronto, Ontario

MRK-00242474-A0

February 26, 2018

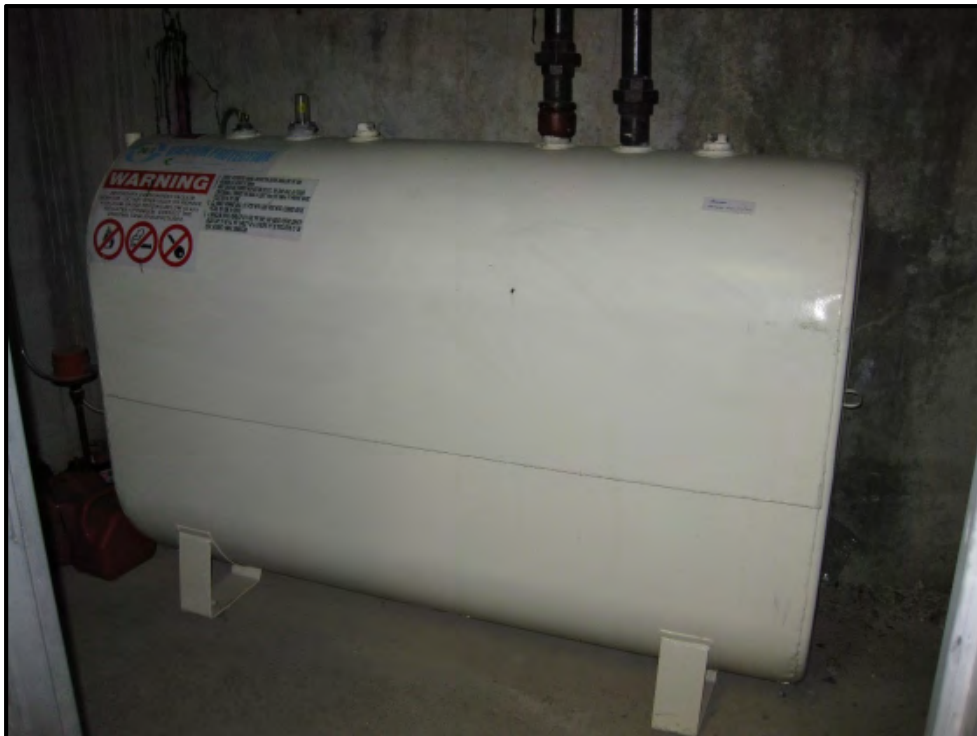
Photograph 12: View of the AST containing diesel for the back-up generator, located in the parking garage at 11 Yorkville Avenue (October 11, 2017).

An AST containing diesel, used to supply the back-up generator, was observed in the east portion of the underground parking garage. The AST is of double-walled, steel construction with a capacity of 935 litres. According to the placard, the tank was manufactured in February 2011. The tank was in excellent condition. Vent/fill pipes for the tank were observed at grade, along the east wall of the building. The presence of the AST was identified as a PCA that would contribute to an APEC.

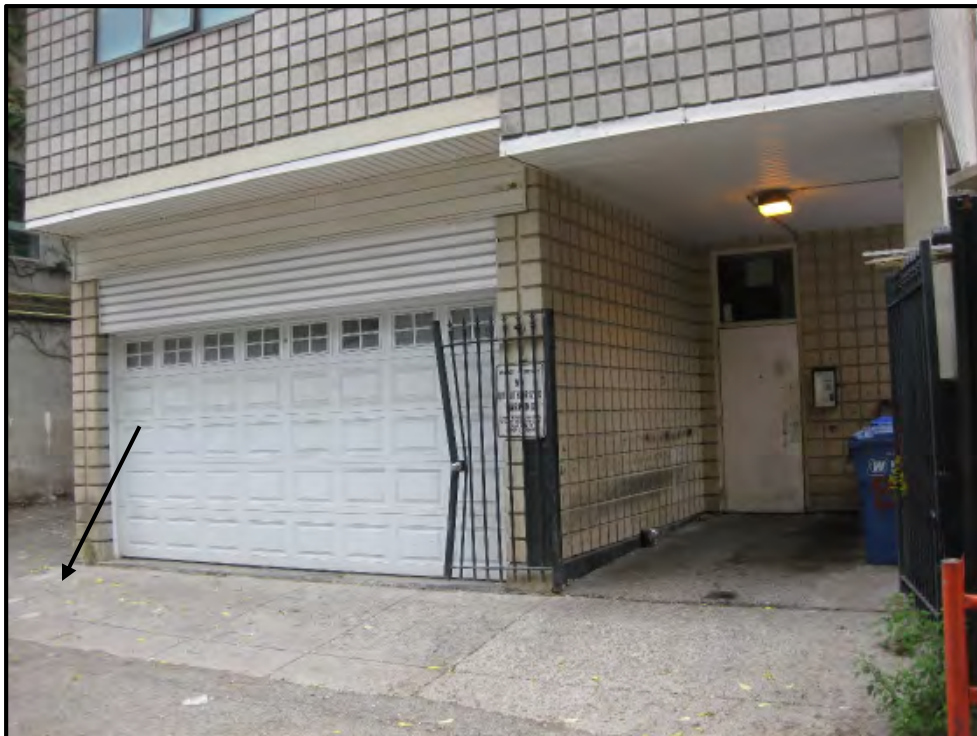
Photograph 16: View of the south face of 17 Yorkville Avenue, looking north (October 11, 2017). The location of previously installed monitoring wells are indicated by the arrow.

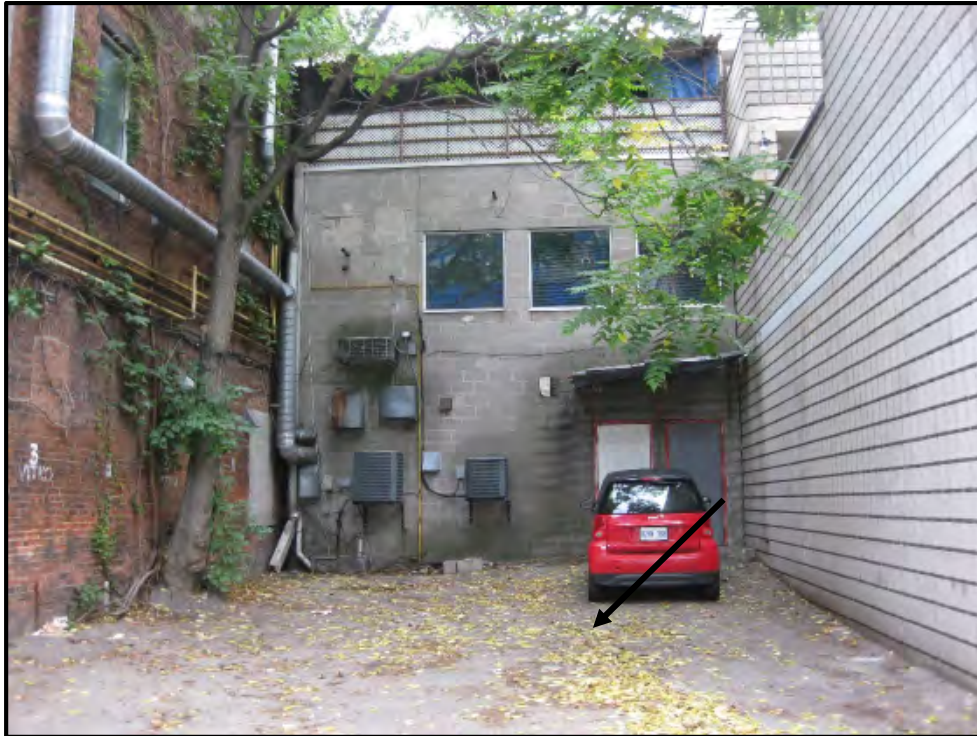
Photograph 17: View of the south face of 19 Yorkville Avenue, looking north (October 11, 2017).
The approximate location of a previously installed monitoring well is indicated by the arrow.
